How's My House Home Inspections LLC

Property Inspection Report

319 XYZ street, Anytown New York, 11121
Inspection prepared for: John Sample
Agent: Real Estate - ABC Realty

Inspection Date: 1/12/2011 Time: 4 PM
Age: Approx 55 Size: Approx 1200 Sq Ft
Weather: Cloudy, 40 Degrees

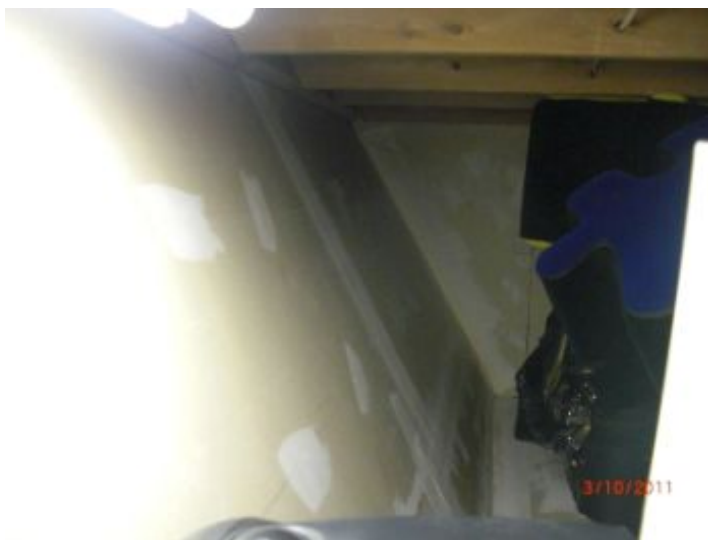
- There were signs of paint and drywall cracking on the ceiling. The area was tested with a moisture meter at the time of the inspection and showed high moisture. This should be monitored for further damage or possibly water intrusion.

no evidence of leaks in knee wall storage area

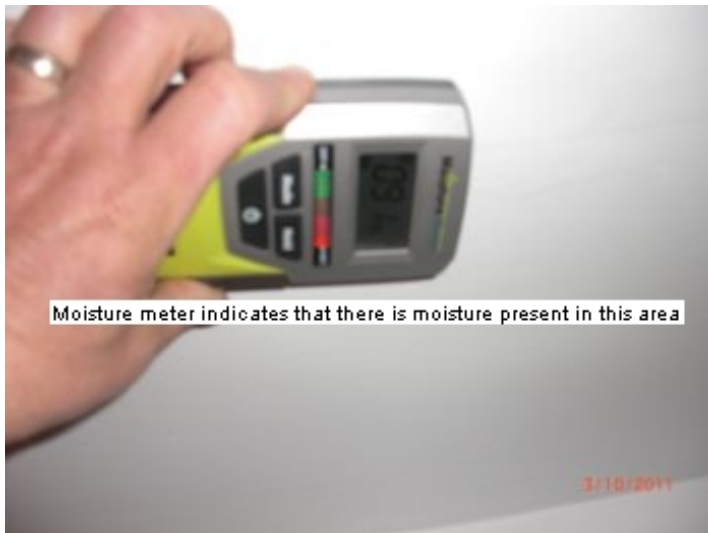
- Minor damage from what appears to be from excess moisture was found on the master bedroom ceiling.
- There were signs of paint and drywall cracking on the ceiling. The area was tested with a moisture meter at the time of the inspection and showed high moisture. This should be monitored for further damage or possibly water intrusion.

Moisture meter indicates that there is moisture present in this area

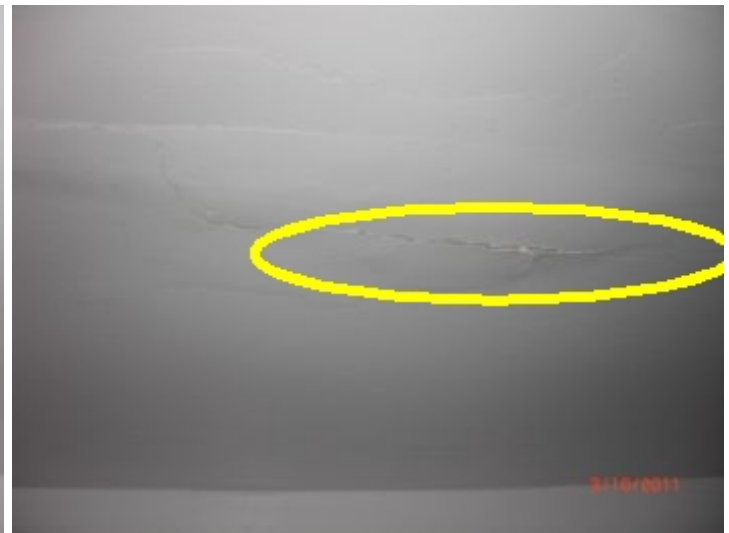
Evidence of a leak is beginning to appear in the master bedroom

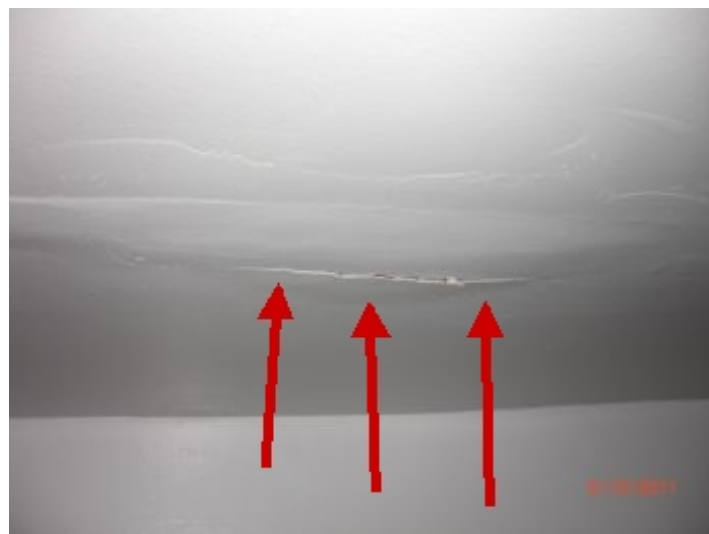
Evidence of a leak is beginning to appear in the master bedroom

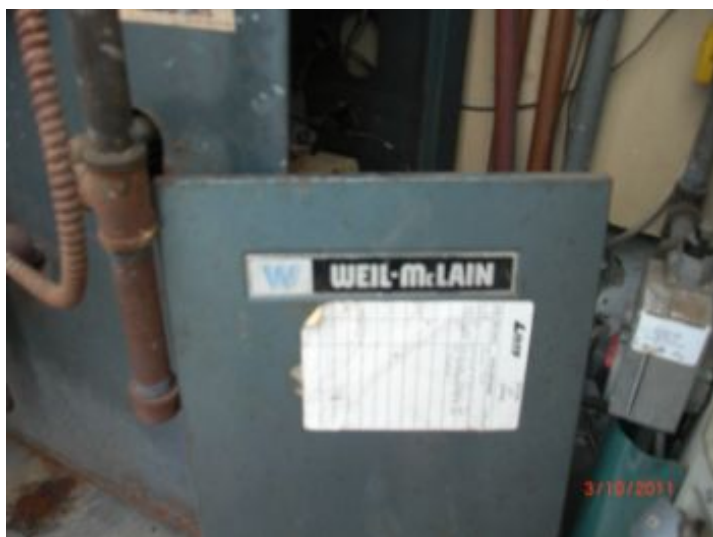
- According to the manufacture the boiler in the house was produced from 1977 to 1980. This would make this unit over 30years of age. There are much more efficient boilers available today and I would recommend you speak with a qualified HVAC professional about your options.

Weil - McLain boiler. Model pcg-4 series 6

Recommend having the unit serviced as soon as you move in.

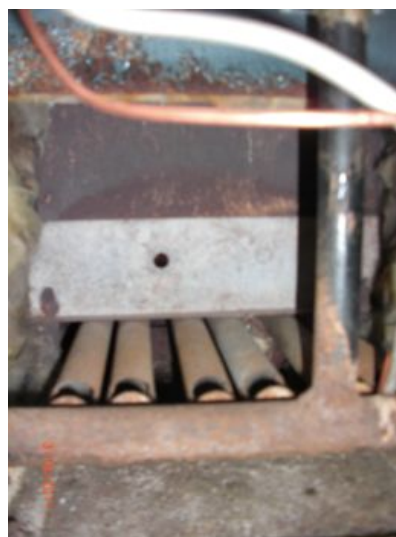
Rust in boiler

- The heater base shows signs of water damage. Possible prior water intrusion as evidenced by rust in the boiler.

- IMPROVE: The furnace is dirty and there are no records of prior service. Recommend an HVAC contractor perform a system Clean-and-Check. HVAC systems require yearly maintenance.
- Due to presence of rust, scale, and some debris in this furnace, a professional cleaning and service review by a licensed HVAC contractor is highly advised to ensure proper and safe operation of this unit. Inspection for holes and/or cracks in heat exchanger is not within the scope of this inspection and should be performed by a HVAC contractor prior to ensure the proper and safe operation of this system.
- Suggest having this unit professionally cleaned and tuned to ensure proper and safe operation.

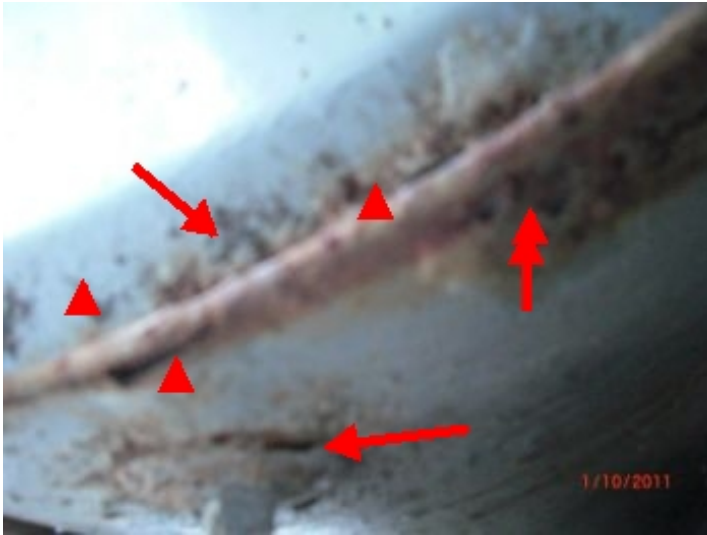
- Oil Tank is rusting and corroding. It is our opinion that it has reached the end of its useful life. Recommend that a qualified contractor be contacted for replacement options

Oil Tank is Rusting

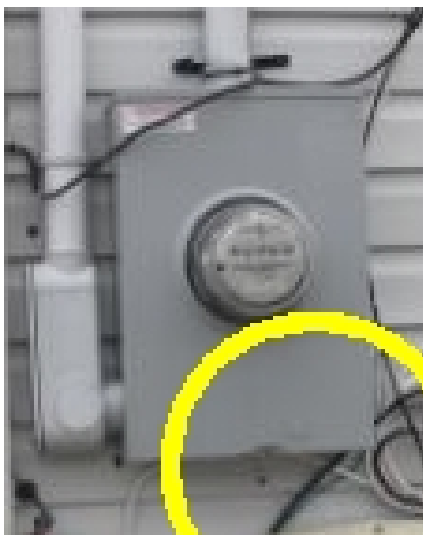
Electrical meter missing locking tab

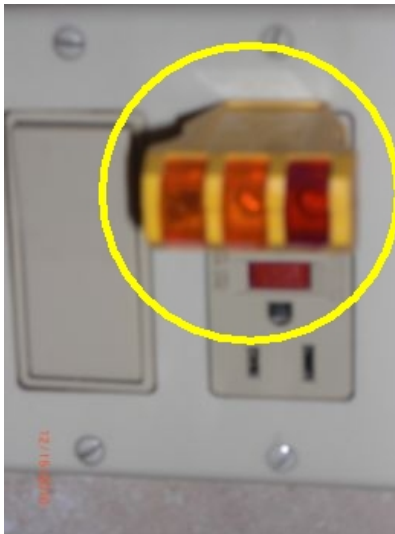
- Some open grounds present in the house. Recommend contacting a qualified electrician for repair.

Open ground in main living room

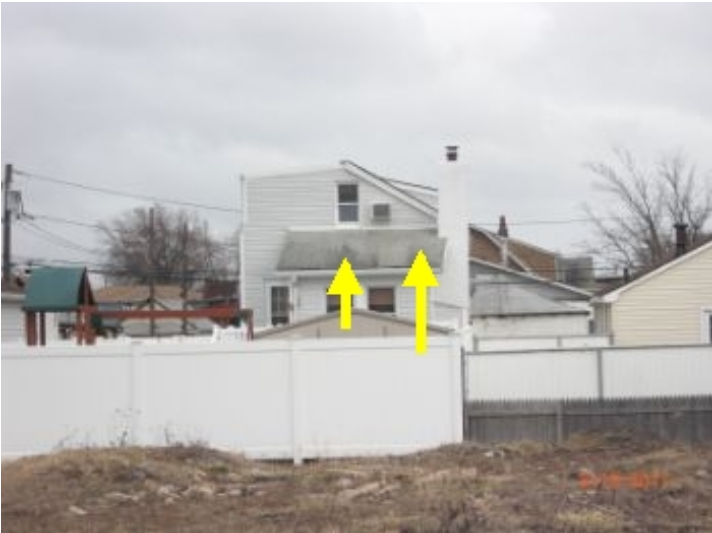
Algae staining is present on the rear part of the roof

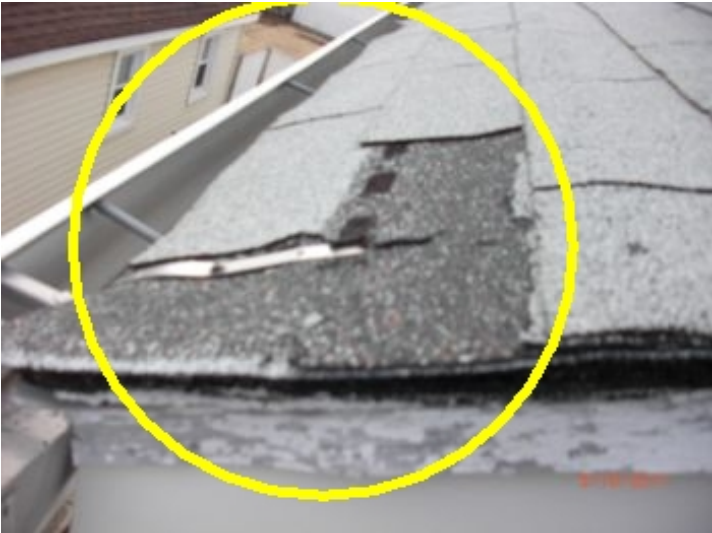
missing shingles on front shed roof

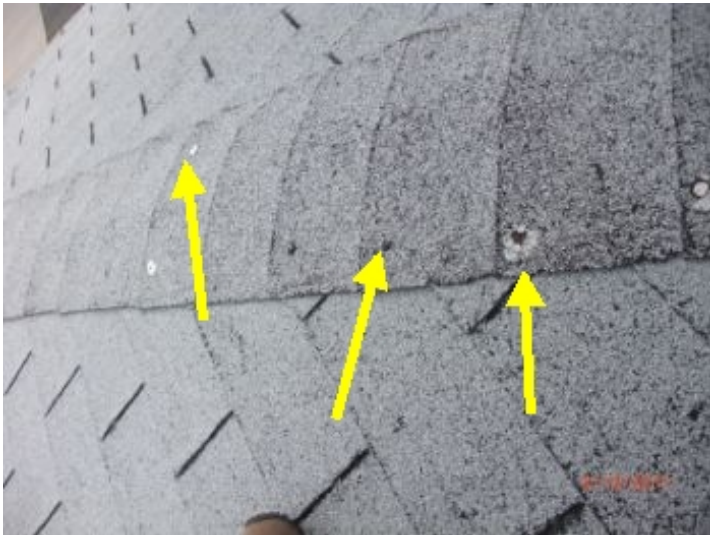
Evidence of roof repair (shingle are nailed on lower section)

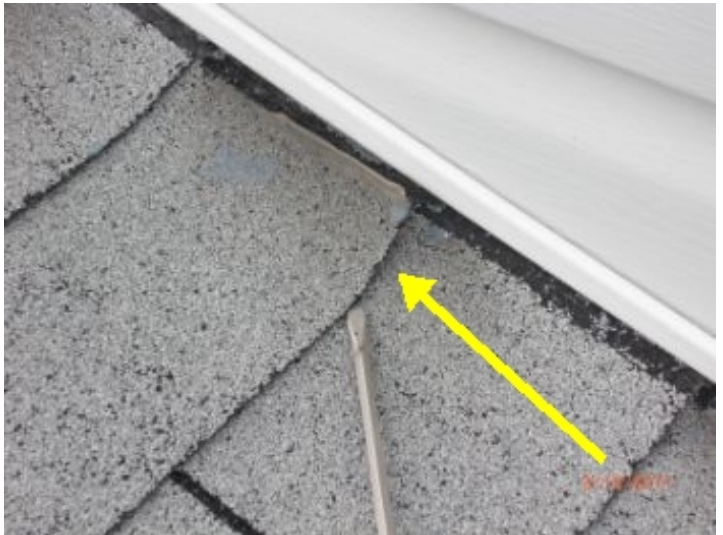
Shingles are peeling up. This was located on the front shed roof.

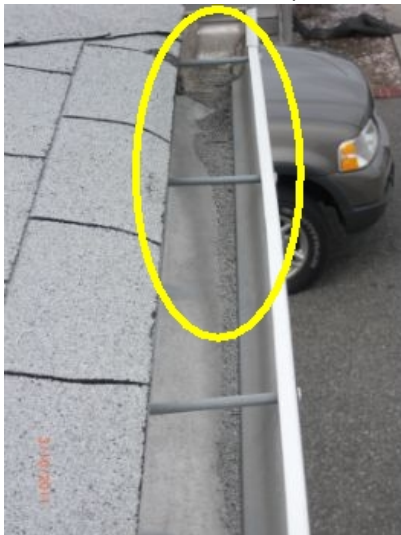
Roof granule is present in gutters

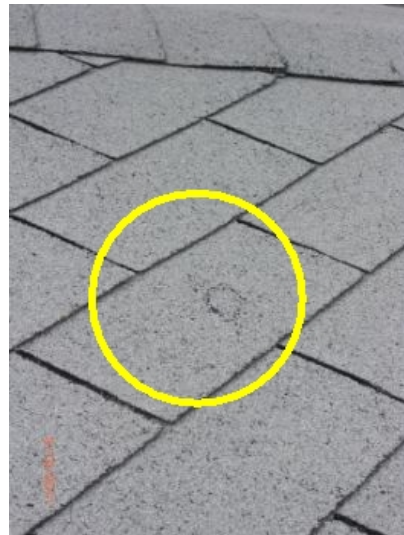
cracks in roof shingles

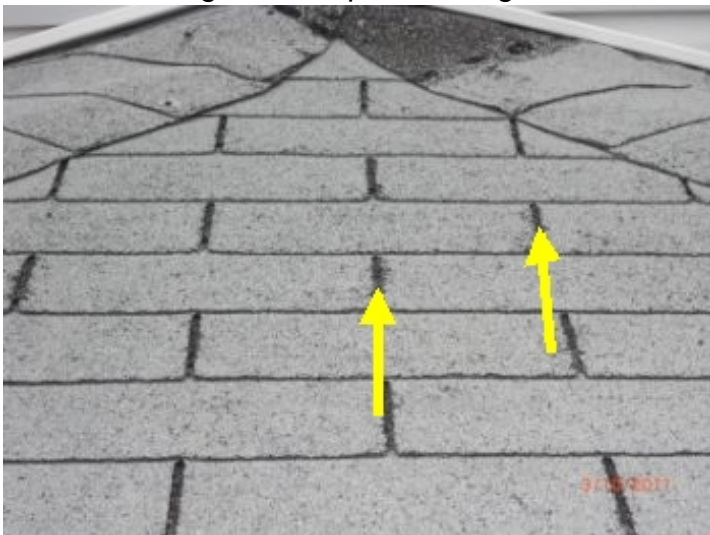
spacing between roofing shingles suggests roof is getting towards the end of its useful life

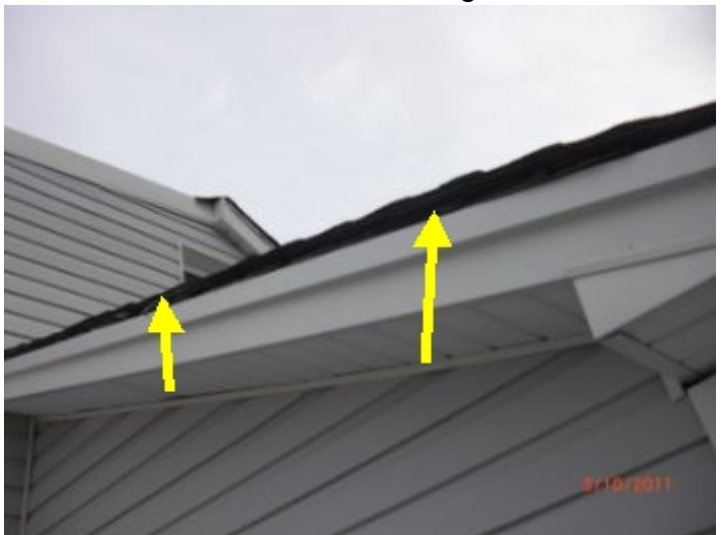
Multiple layers are present on the back part of the roof

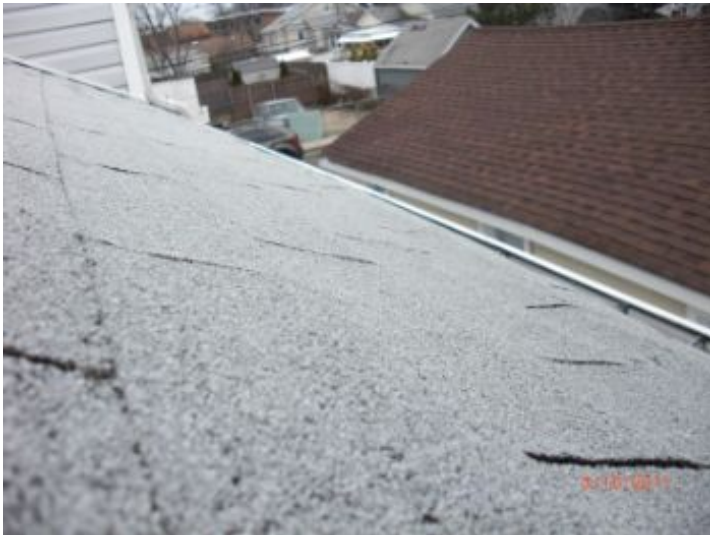
Roof is wavy at the back of the house

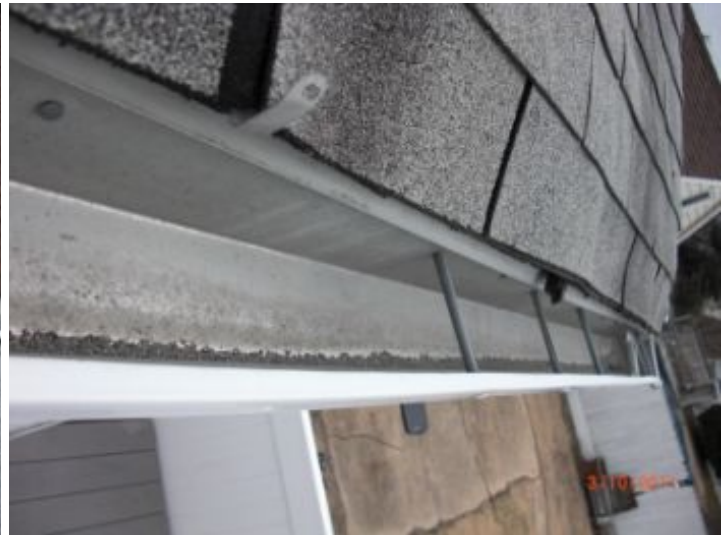
roof granules in gutter

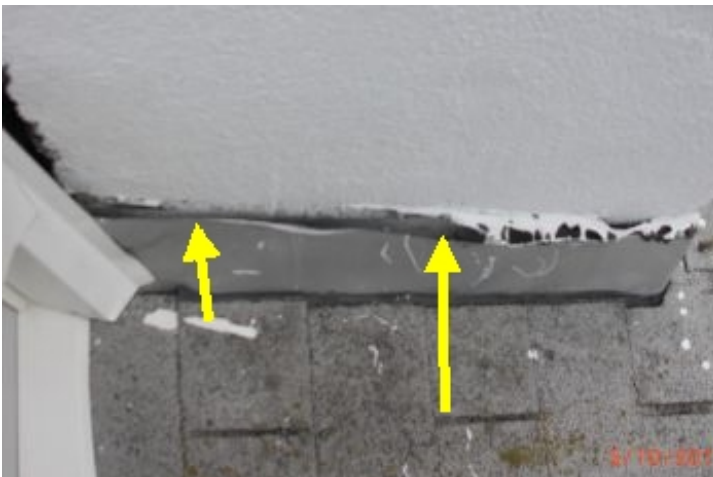
Page 28 Item: 3	Chimney	<ul style="list-style-type: none"> flashing at the roof is poor and ineffective. This is leading to water / moisture intrusion in the boiler room, as evidenced of rust in the boiler. Flashing at base of chimney appears to need some maintenance to ensure a continued waterproof seal. Recommend review by a qualified chimney professional for repair or replacement, as necessary, prior to close.
Exterior Areas		
Page 31 Item: 3	Siding Condition	<ul style="list-style-type: none"> A Small crack was seen on siding at the front of the house
Page 32 Item: 4	Eaves & Facia	<ul style="list-style-type: none"> Paint on some of the trim around the eaves is failing and should be scraped and painted Soffits at the home appeared to be in serviceable condition at the time of the inspection.
Foundation		
Page 33 Item: 3	Foundation Walls	<ul style="list-style-type: none"> Evidence of past water penetration observed.

Improper flashing between roof and chimney

- Flashings are mastic covered, recommend re-sealing all through the roof vents and projections as a part of routine maintenance.
- Recommend review by a licensed roofer for repair or replacement as necessary.

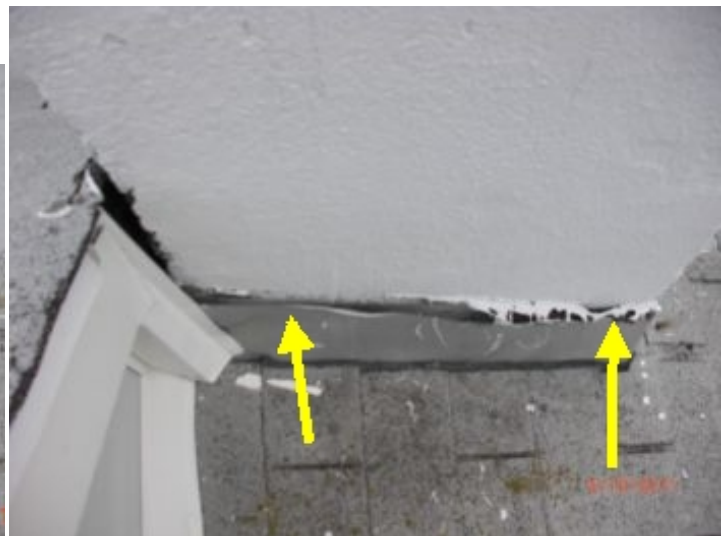
Improper flashing at roof and chimney

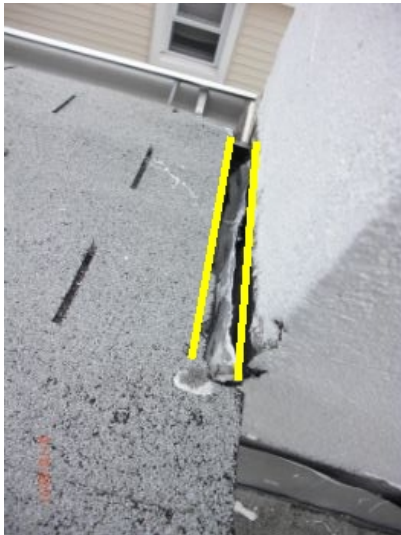
Improper flashing at roof and chimney resulting in a gap between roof and chimney

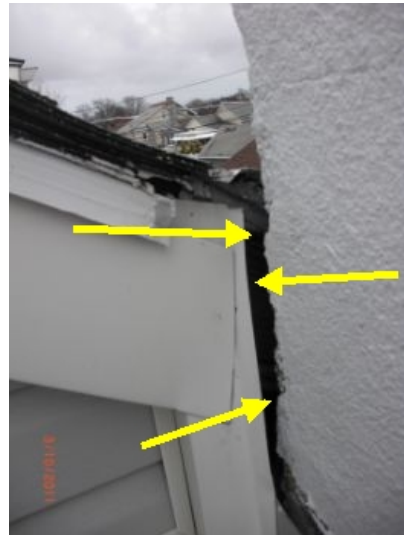
gap between chimney and house

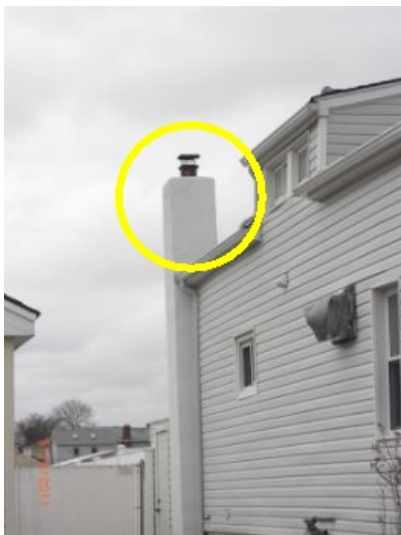
- Chimney brick has been painted.
- Chimney Mortar shows sign of deterioration. Recommend having repaired as necessary.
- Brick and mortar deterioration observed; repair advised.
- flashing at the roof is poor and ineffective. This is leading to water / moisture intrusion in the boiler room, as evidenced of rust in the boiler.
- Flashing at base of chimney appears to need some maintenance to ensure a continued waterproof seal.
- Recommend review by a qualified chimney professional for repair or replacement, as necessary, prior to close.

Minor cracking on the on the chimney

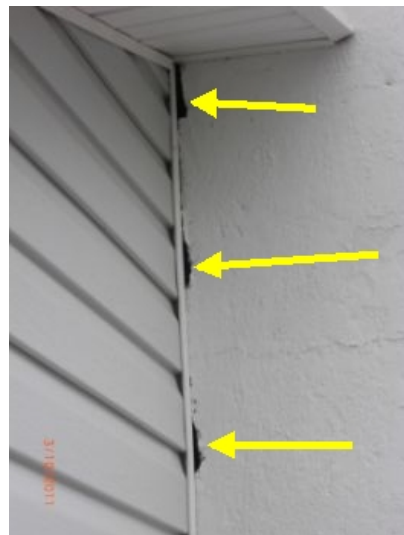
Evidence that chimney is leaning away from house.

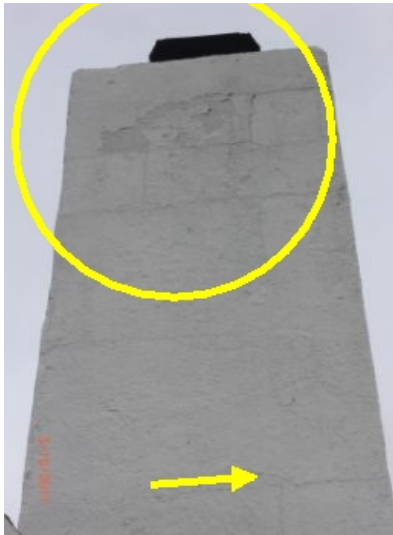
Cracking and peeling paint present on chimney

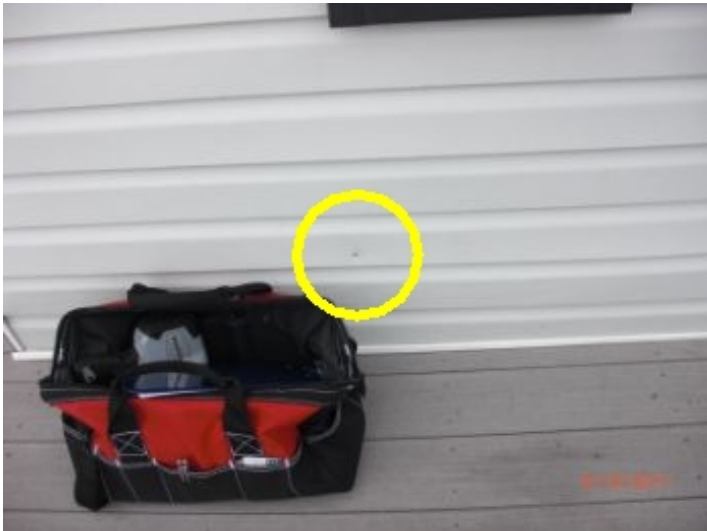
small crack in siding at front of house

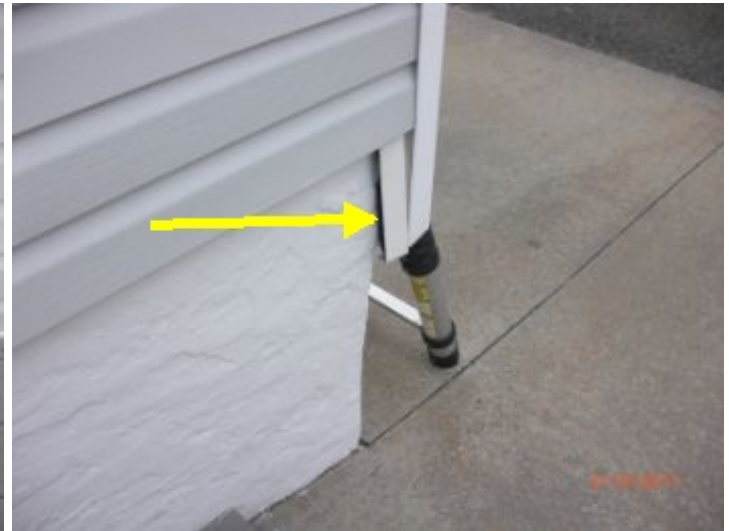
trim is cracked and pulling away from house (front corner by driveway)

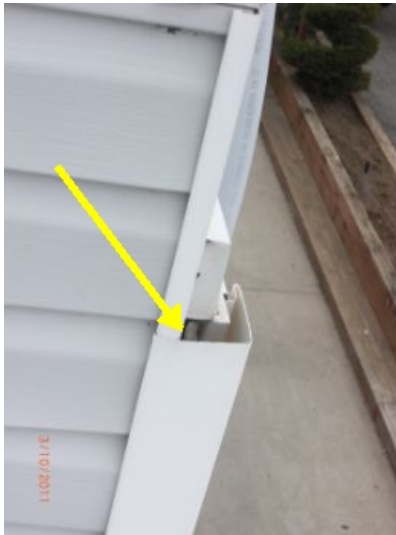
Trim is open to elements.

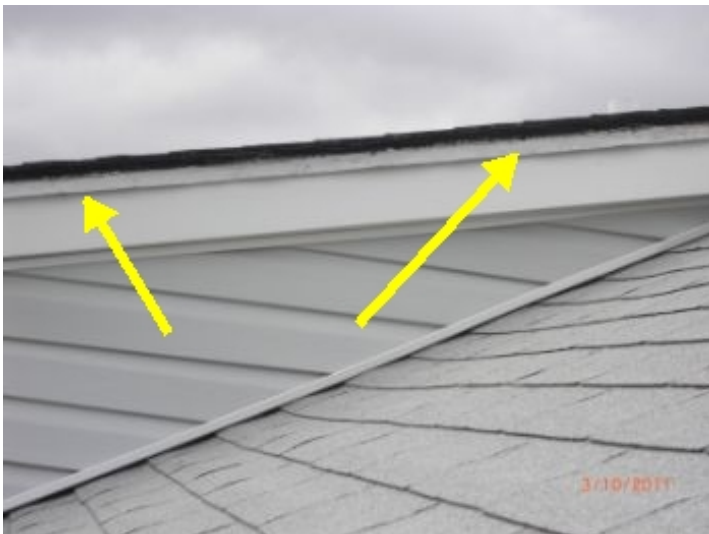
Peeling paint, needs to be scraped and painted

- Peeling paint observed (on eaves), suggest scraping and painting as necessary.
- All exterior painted wood trim surfaces should be annually examined and sealed, re-caulked and re-painted as needed.

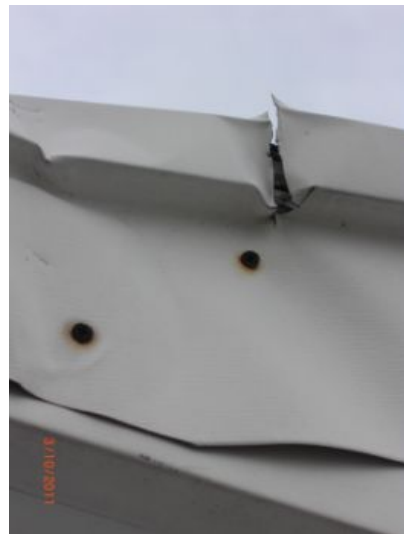
cracked/ ripped trim at rear of house

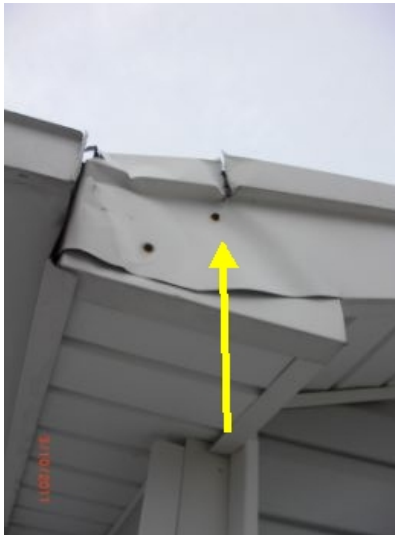
Cracked/ ripped trim at the rear of house

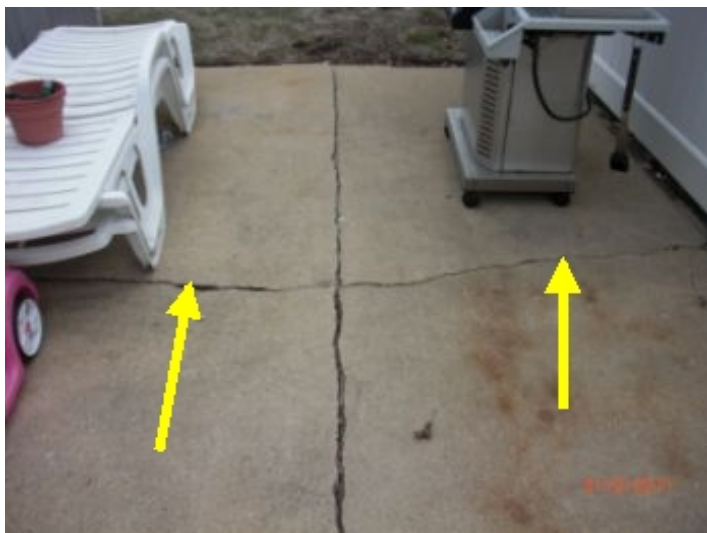
- Driveway in good shape for age and wear.
- There are minor predictable and common cracks in the concrete . Monitor these areas for further movement or expansion and repair/seal as needed to prolong life
- **IMPROVE:** Typical cracking was observed at the concrete surfaces. Further deterioration will occur as water expands and contracts from freeze and thaw cycles. Recommend sealing the cracks to prolong the life of the concrete.

Minor cracks in rear patio

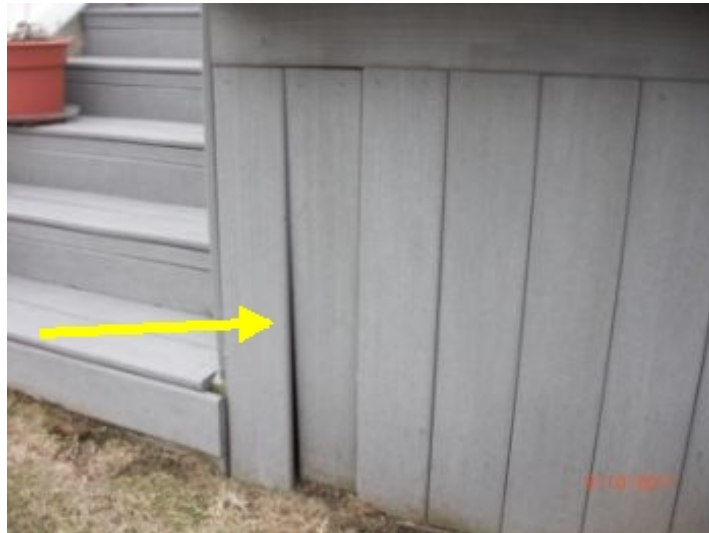
Loose side board on deck

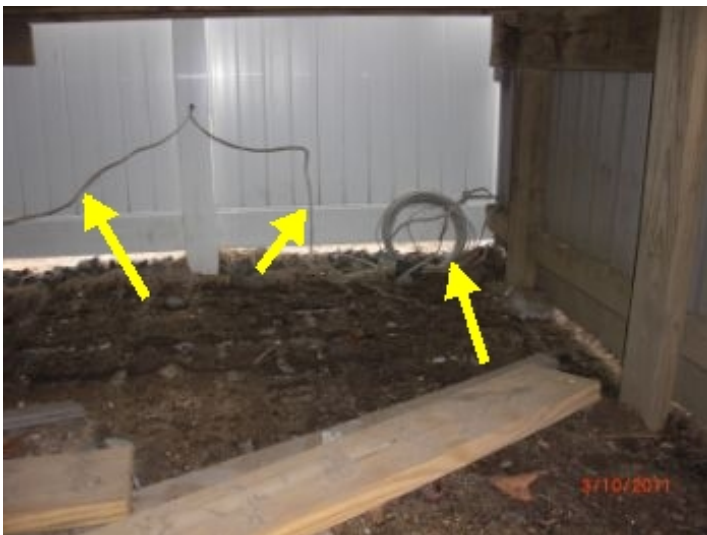
- Wire for outdoor lights is loose under the deck and is not buried that far below ground. Recommend that you have a qualified electrician secure these wires and make sure that properly buried. Improperly buried wires can result in damage from a shovel or othe sharp object being driven into the ground.

loose wire for outdoor lighting under deck

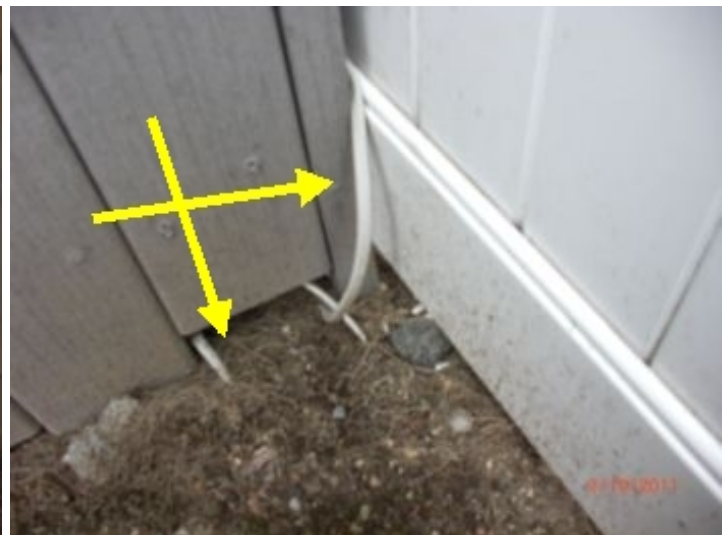
loose un buried wire for outdoor lights

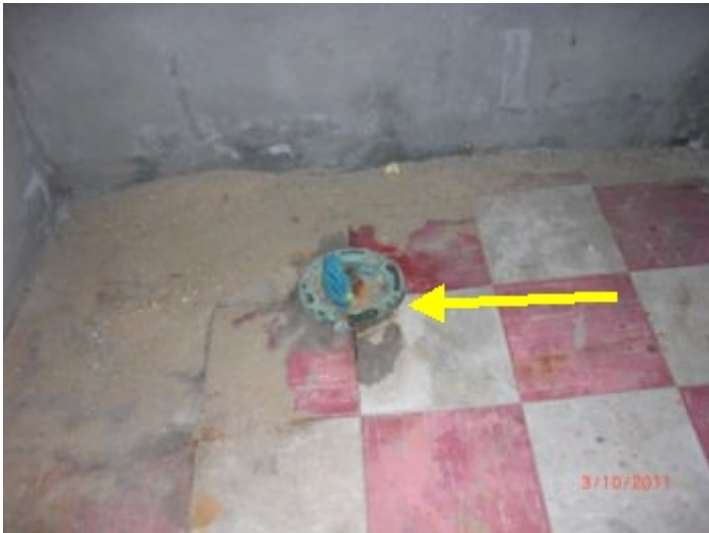
old flange for what appears to be a toilet in the basement

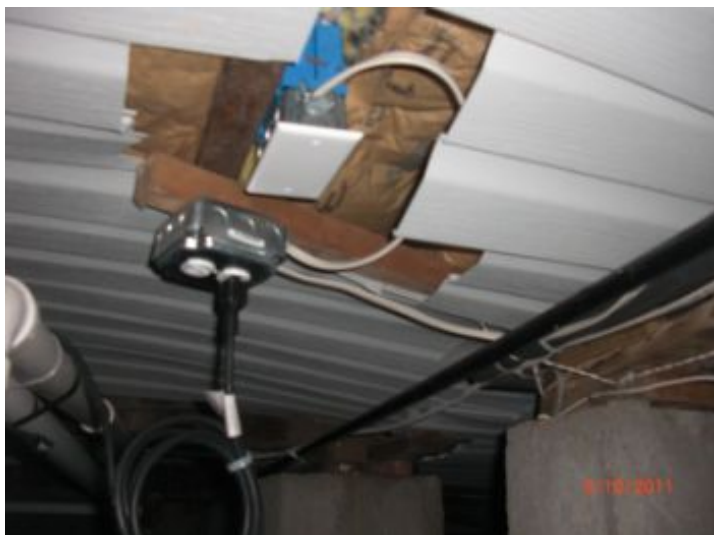
Basement outlets should be GFCI

- There is no GFCI protection for the basement outlets. Due to the nature of flooding in the basement I recommend that you have a qualified electrician install GFCI outlets.

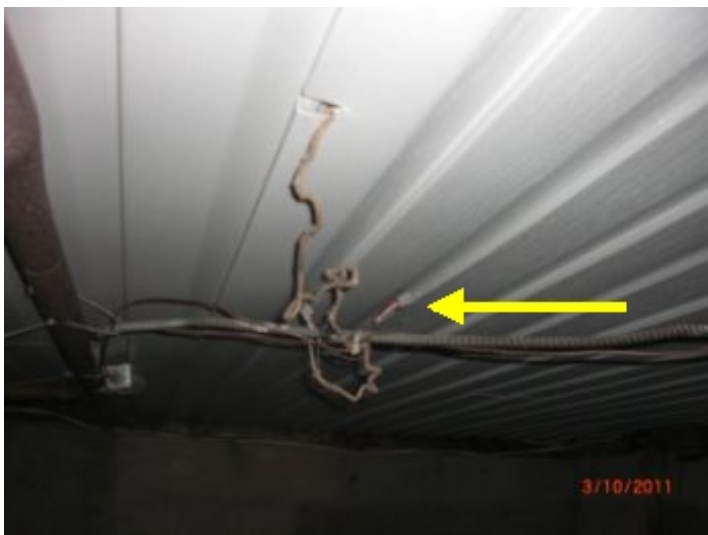
- Open connections were visible in the basement during the inspection. The line did not appear to be live when tested but you should have a qualified electrician exam it.

open junction

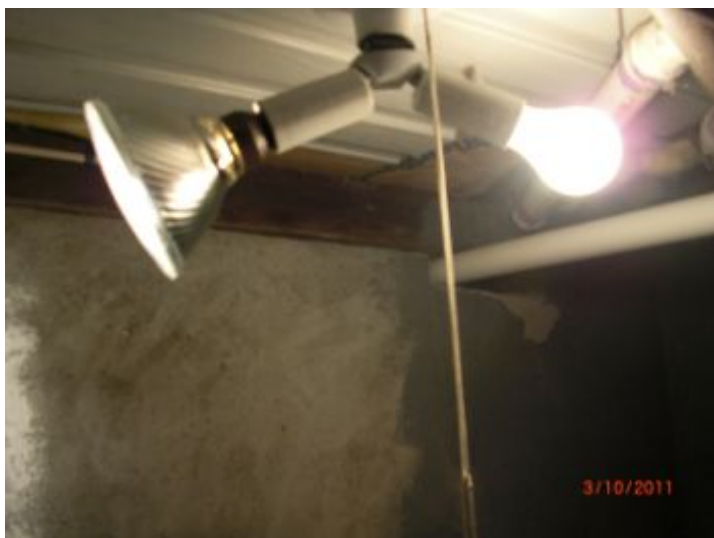
loose light fixture

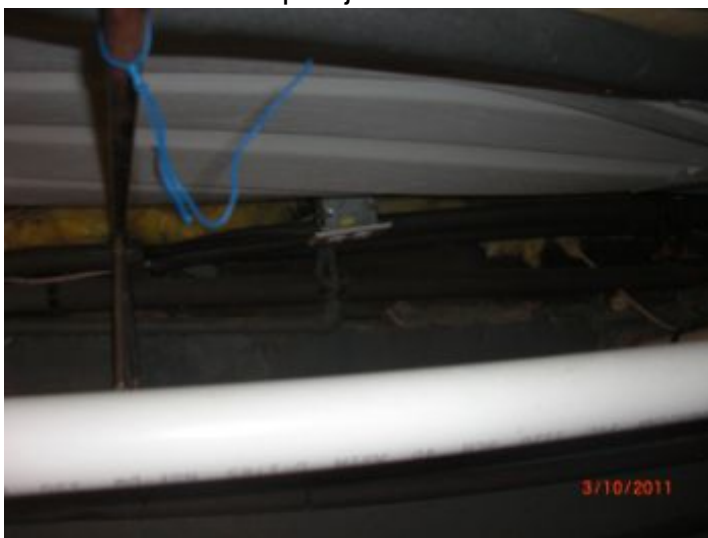
Outlets in basement should be GFCI due to flooding

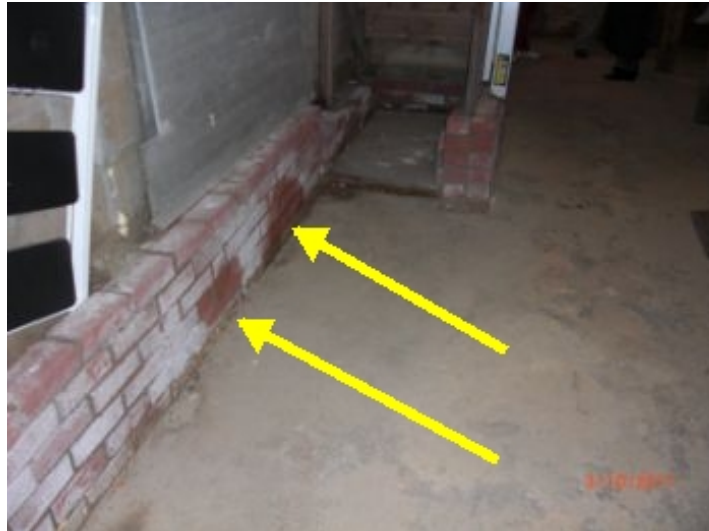
- Recommend further review of current perimeter foundation drainage system by a Qualified Foundation Drainage Contractor. Drain pit appears to be insufficient and may allow water to enter structure in the event of a heavy rainfall.

evidence of past flooding in basement
